ENGINEERING SEISMIC INVESTIGATION

VILLAGE OF PAGUATE, NEW MEXICO

Administrative Report

August 29, 1986

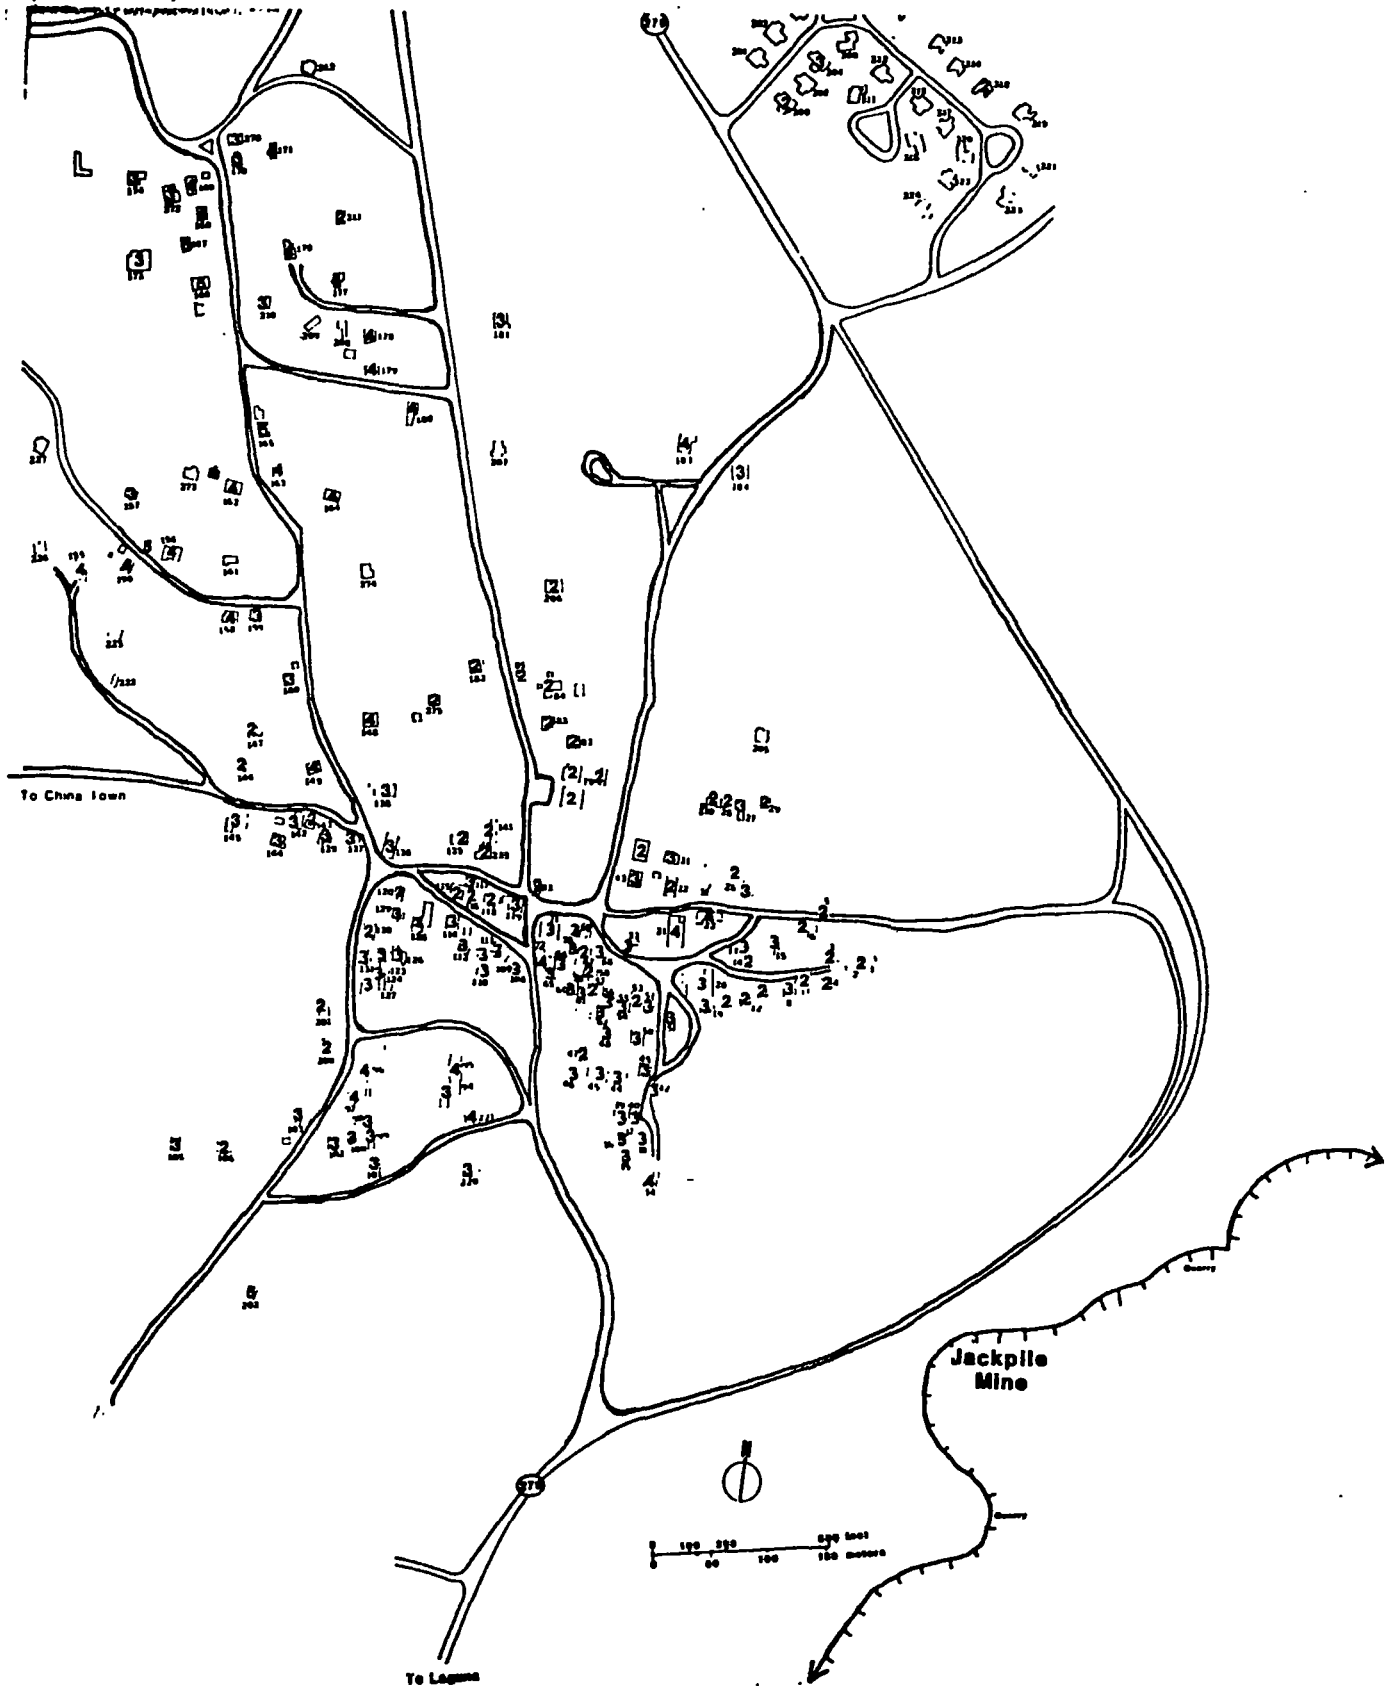
Figure 2.—Map showing the village of Paguate and the distribution of building damage using the scale shown in Table 1. Degree of damage shown by large numbers. Small number adjacent to the building is used to identify that structure in the text.

The damage survey in the village of Paguate shows an overall intensity pattern that is irregular in areal distribution and is not related to distance from the Jackpile open-pit mine. The most heavily damaged structures are generally located in clusters of buildings which are located farther from the mine than are lesser-damaged structures. The main parameters that might contribute to or may be the cause of the observed damage to the buildings in the village are: shrinkage of building materials, thermal and moisture-activated expansion and contraction of building materials, construction methods (poorly constructed lintels, vigas, bond beams, etc.), differential compaction under the foundations, and/or vibration damage.

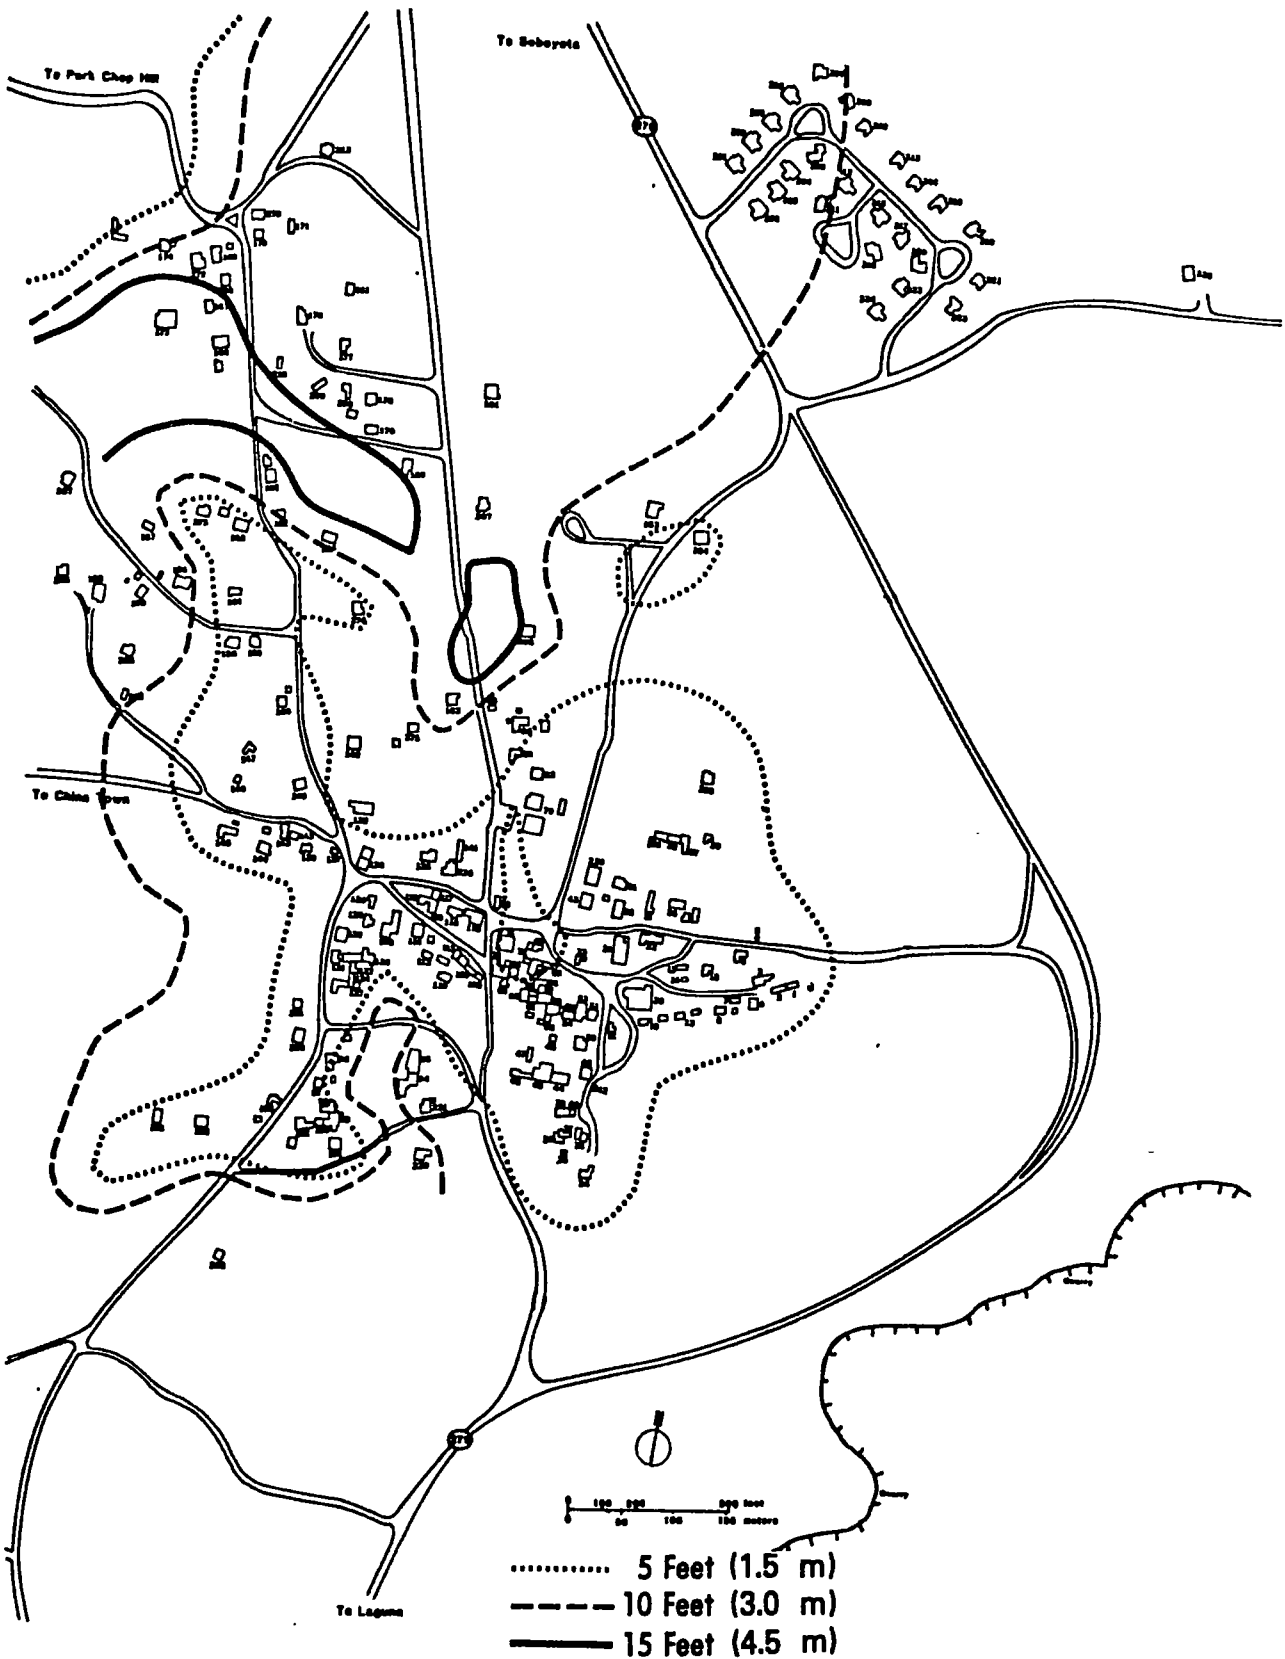
of less than 3,500 ft/s (1,066 m/s) overlying the sandstone bedrock varied from less than 1 foot (.3) in the general area of building 6 to over 15 feet (4.6 m) thick in the areas of buildings 164, 206, and 220 (fig. 6). The thickness of low propagation velocity underlying material exceeds 15 feet in the area of "China Town" and the area west of the village in the drainage valley. Test cores were made to a 24-inch (.6 m) depth near buildings 16, 20, 21, 82, 93, 165, 167, 184, and 308. The coring was inconclusive at buildings 20, 21, and 184 as bedrock was less than 24 inches deep. The core compaction of the cores recovered at the remaining sites was less than 5 percent which gives a general indication of a low compaction susceptibility. A mean void ratio was computed for the samples from site 165 and 167 by the relation $VR = (GS/GD)-1$ where VR is the void ratio, GS is the dry-density and GS is the density of the material without the voids. Core samples were recovered at 4-foot (1.2 m) and 6-foot (1.3 m) depths at buildings 165 and 167. The mean void ratios at the sites tested varied between 0.55 and 0.65. The highest void ratio calculated was 0.65 at 24 inches (.6 m) depth at building 16. No hydrological data or obvious water-induced staining or precipitation, which may indicate a changed water table, were detected in the core samples or bore holes.

Figure 6.—Contour lines showing the thickness of low velocity (seismic propagation velocity) materials as measured by seismic refraction methods and auger holes. Low velocities are those less than 3500 ft/s (1066 m/s).

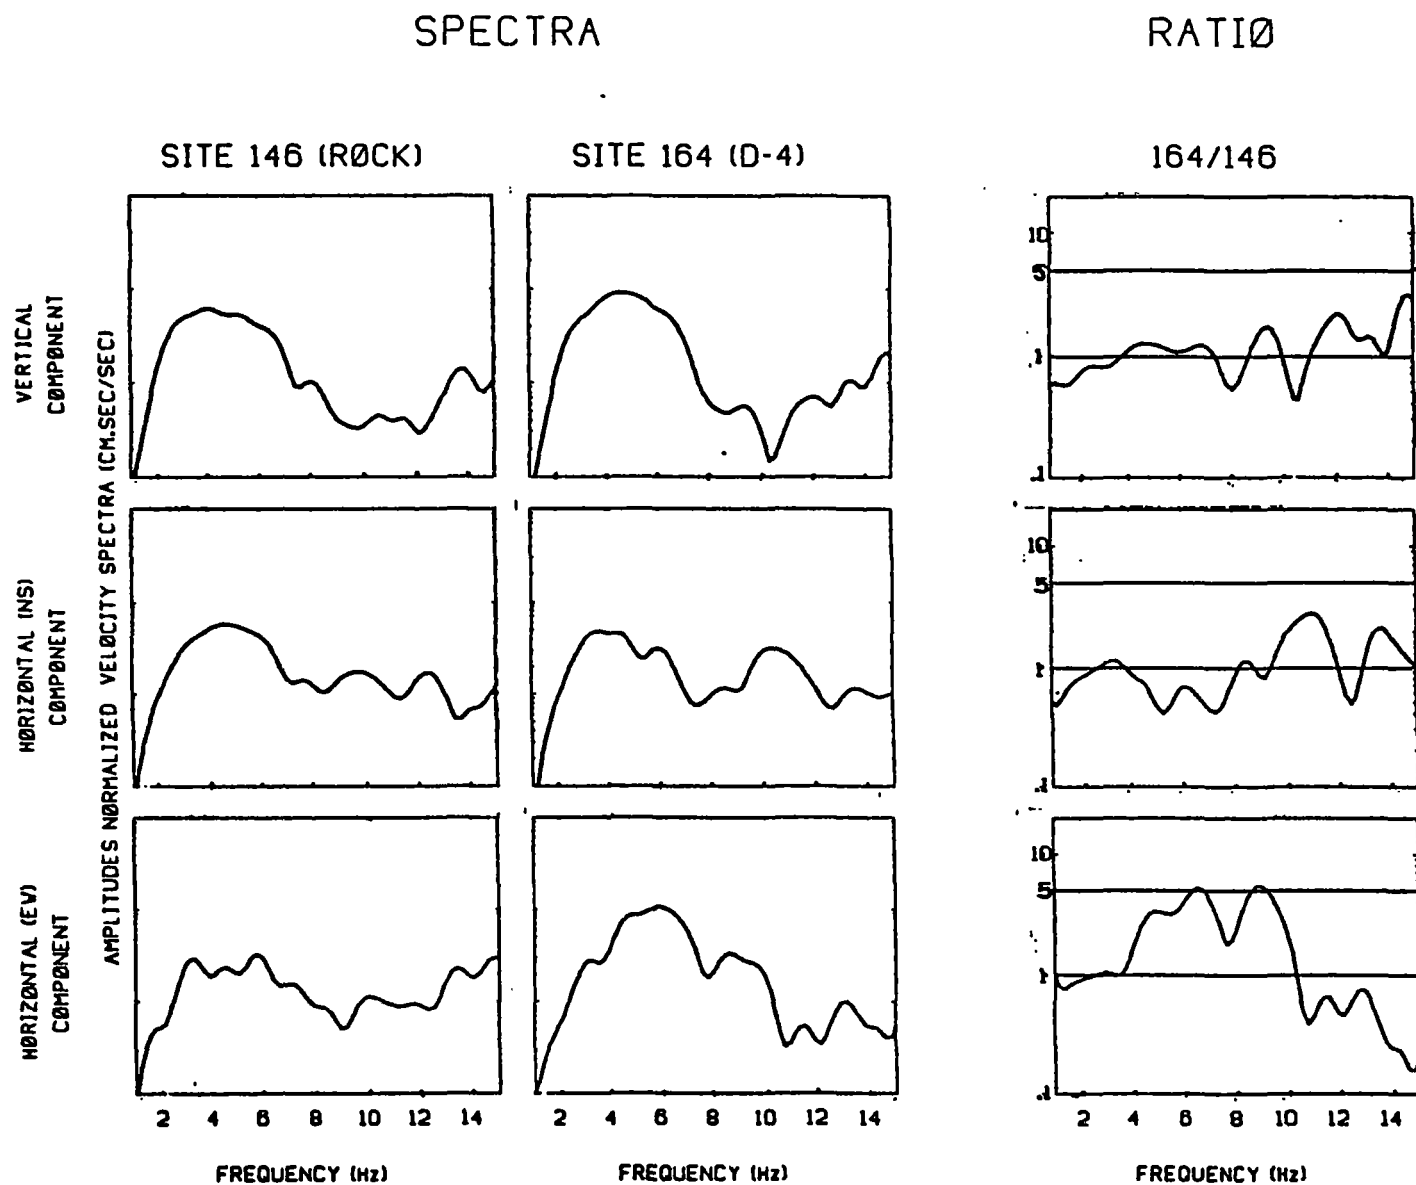
The spectral ratios between the rock site and site 164 (damage rating of 4) show that there is a site amplification of the horizontal ground motion at site 164 in the frequency band of 3.8-10.1 Hz. The peak site amplification of the east-west horizontal component of ground motion at this site is 5.1 at 6.2 and 8.9 Hz. The peak site amplification in the north-south horizontal component is 2.9 at 10.9 Hz (fig. 12). Site 165 (damage rating 5) is 350 feet (107 m) farther from the source than the rock site and also shows a site amplification. The site amplification of the horizontal ground motions at site 165 peaks at a factor of 8.2 at 6.4 Hz in the east-west component and a factor of 3.1 at 13.2 Hz in the north-south component (fig. 13).

Figure 12.--The spectra of three components of ground motion and their accompanying ratios (164/146) show amplification of ground motion at site 164, especially in the east-west horizontal component.

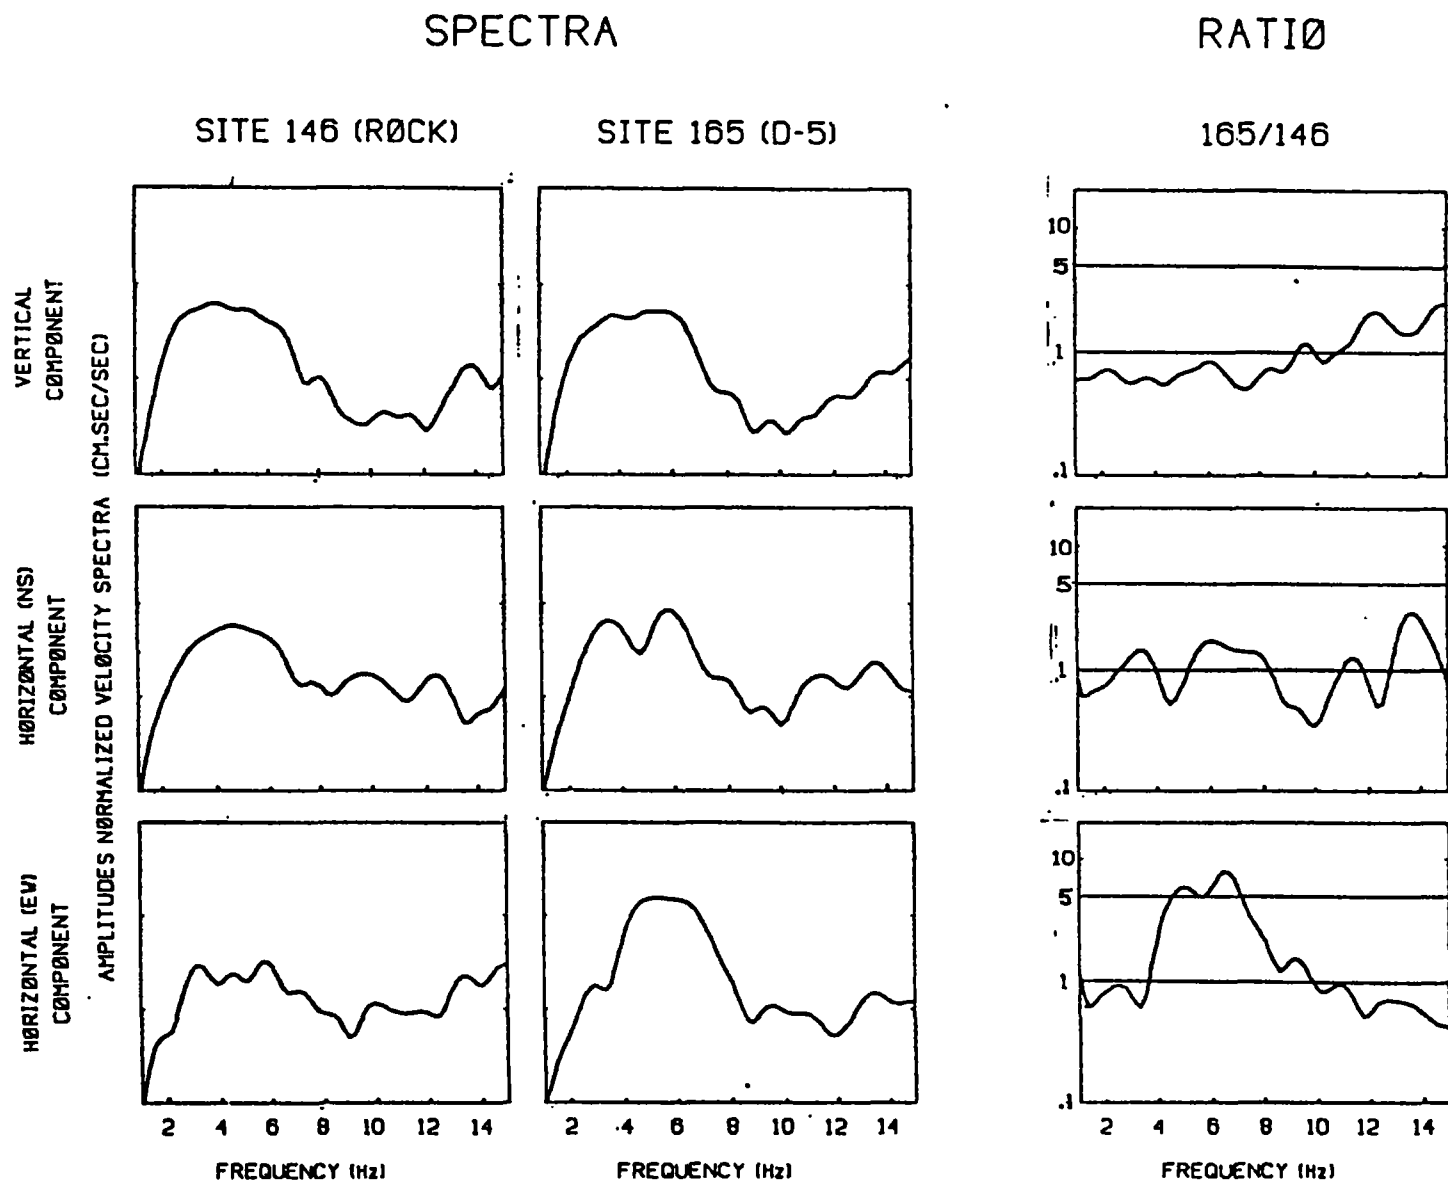
Figure 13.--Compared to site 146, site 165 also shows amplification of ground motion. The strongest amplification occurs in the east-west component.

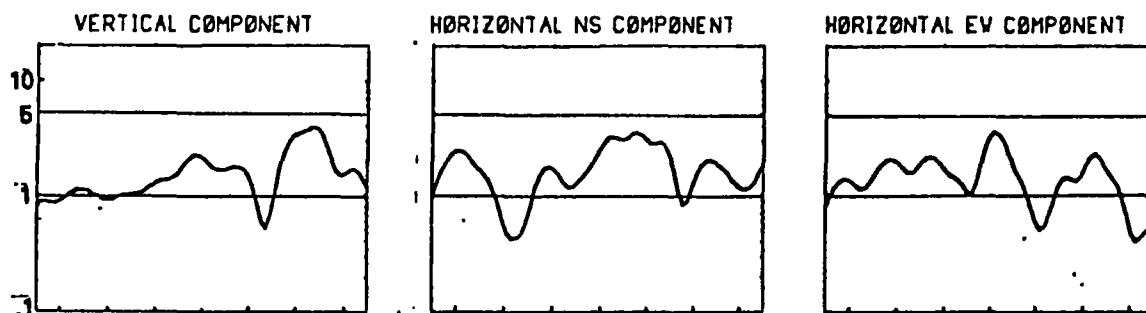
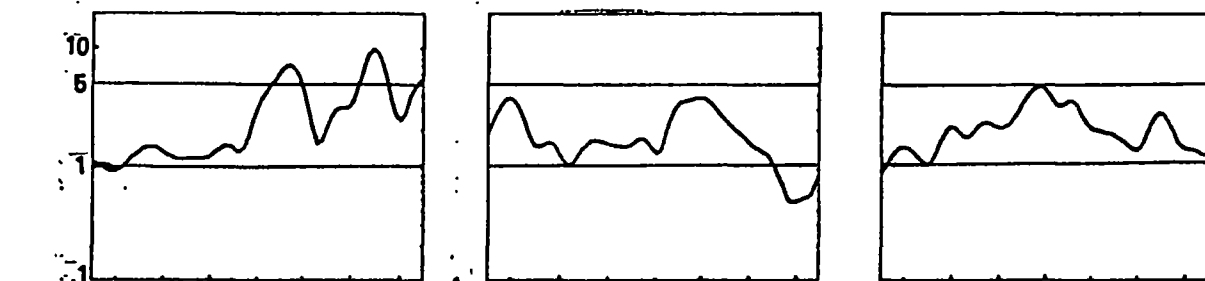
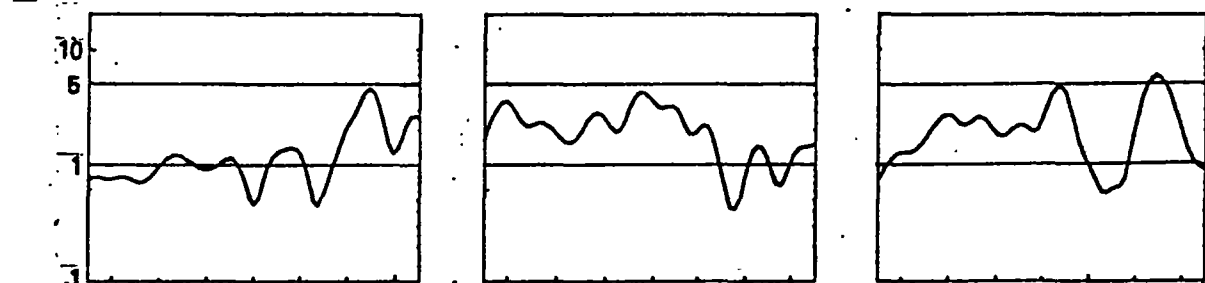
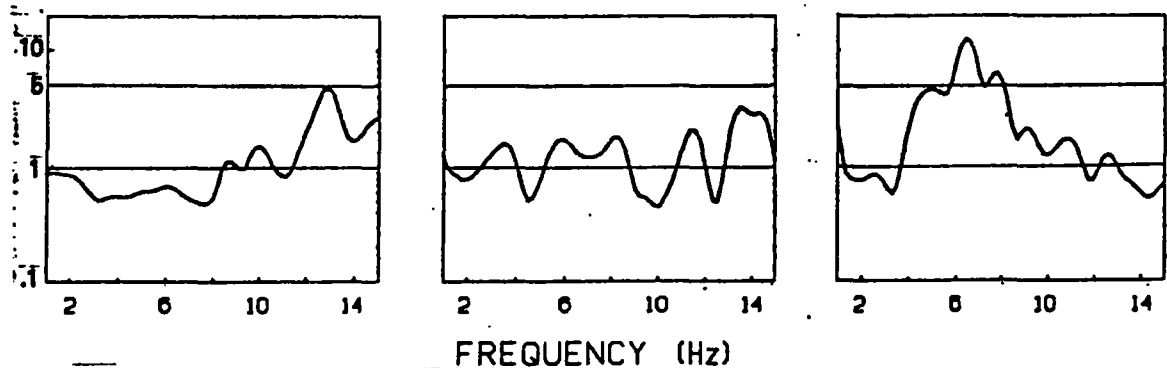
Figure 14 shows the comparisons (ratios) of the spectra between the rock site and several other sites in the village. The ground motion on bedrock can be predicted for the sites in the village and/or factored to the bedrock station based on the attenuation functions calculated in the previous section. The seismic data from several sites in the village were normalized by using the average attenuation functions with the following equations: $A_c/A_s = (R_c/R_s)^{-1.87}$ for the vertical component and $A_c/A_s = (R_c/R_s)^{-1.15}$ for the horizontal component where A_c is the velocity value at the site being compared, A_s is the velocity value at the standard site (rock site or low damage site), R_c is the distance from the source of the site being compared,

Figure 14.--Comparisons (ratios) of the spectra between the rock site and several other sites in the village. The damage scale rating is also indicated for that site.

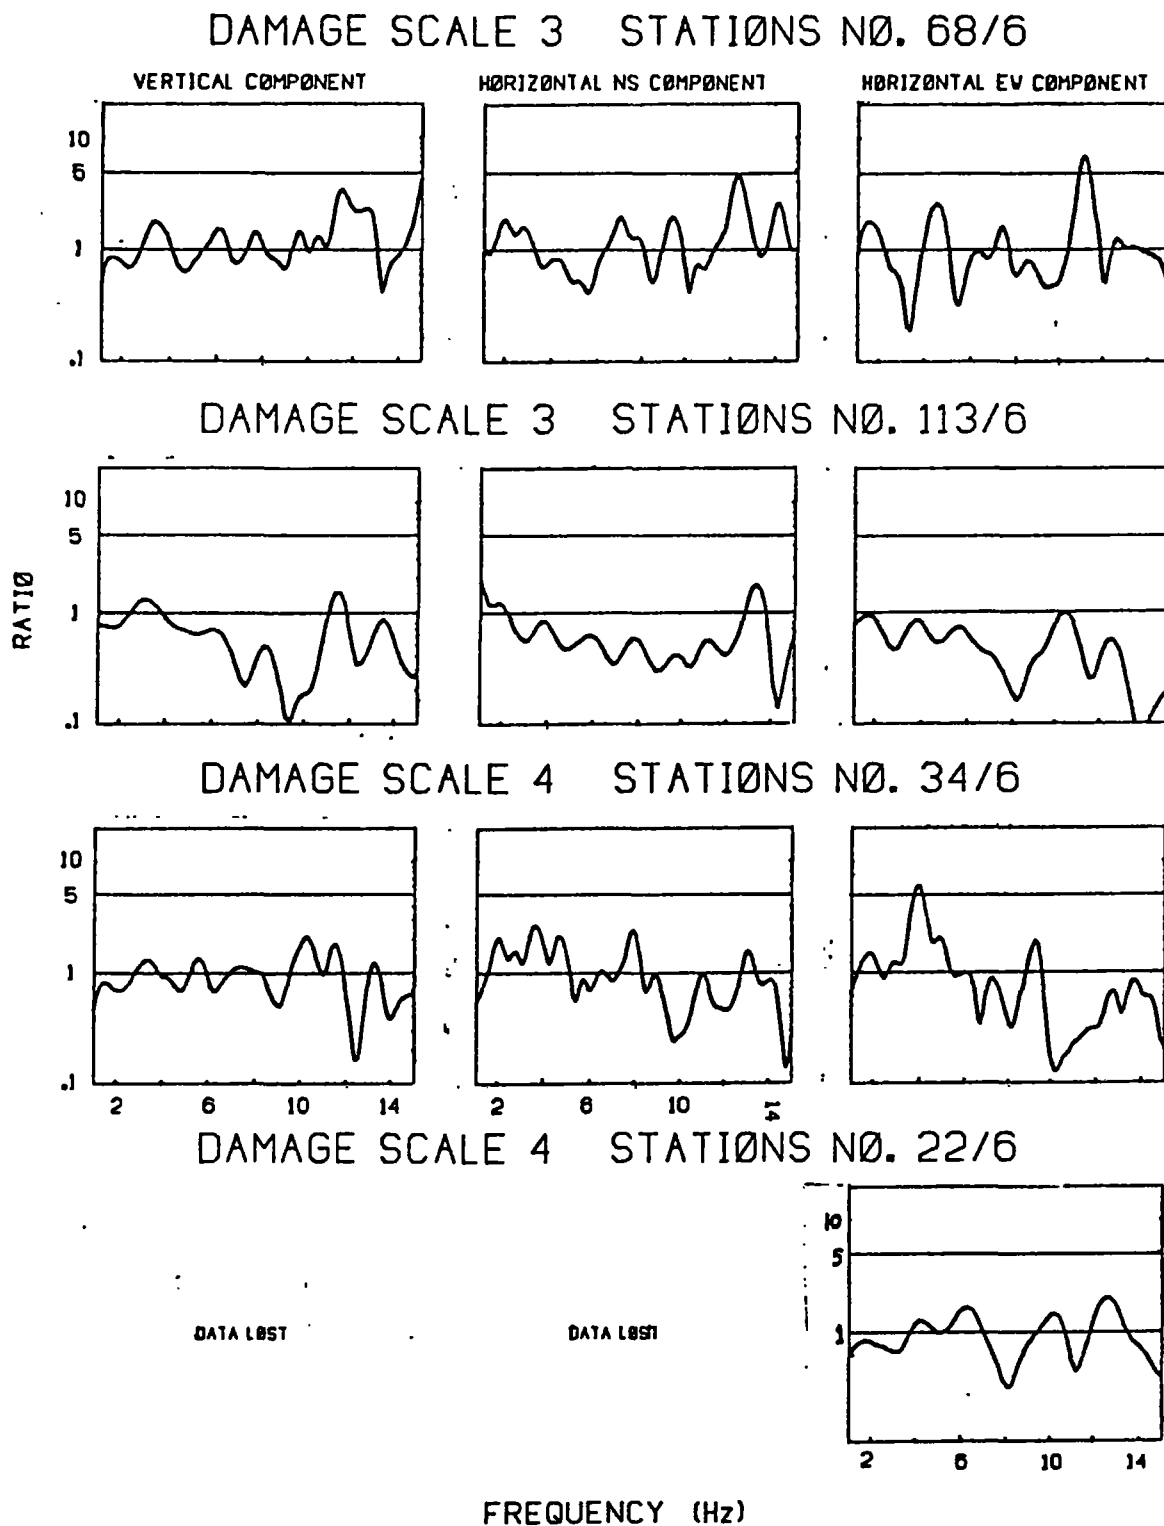
A comparison of spectral ratios was made among the seismic recording sites in the village and a low damage rated (degree 2) site that is closer to the source (2,150 feet; 655.3 m) than the other sites investigated. Spectral ratios at all sites compared show equal or higher ground motions at selected frequencies in the 1-15 Hz band than were recorded at the low damage-close

Figure 15.--A comparison of the spectral ratios for all three components between several sites and site 6 - a low damage rated site (grade 2)- which is closer to the test explosions than the sites to which it is compared. The ratios show equal or higher ground motion at selected frequencies in the 1 to 15 Hz band than were recorded at site 6.

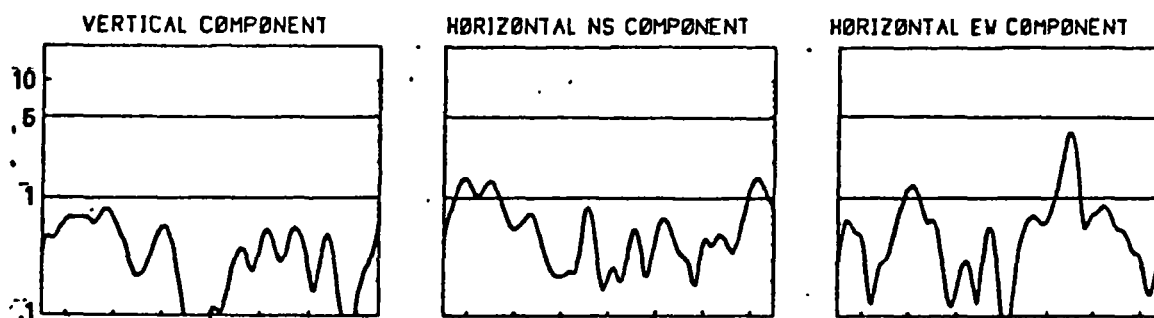
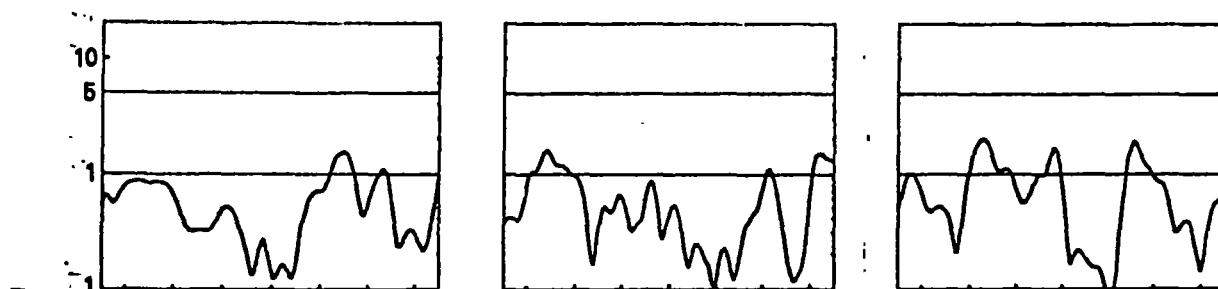
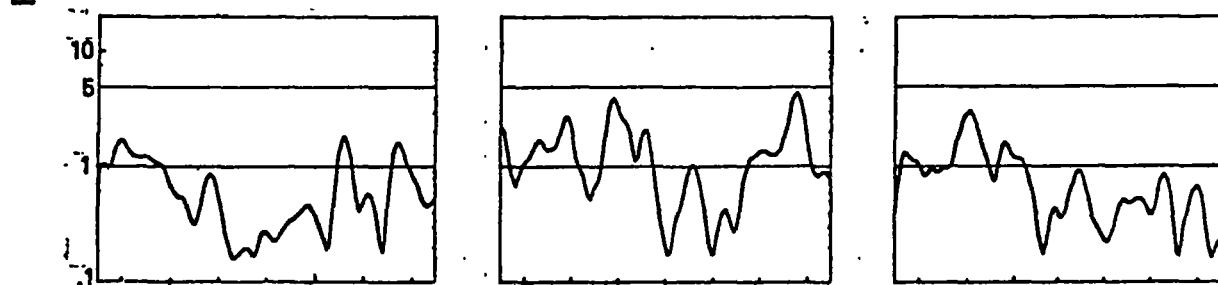
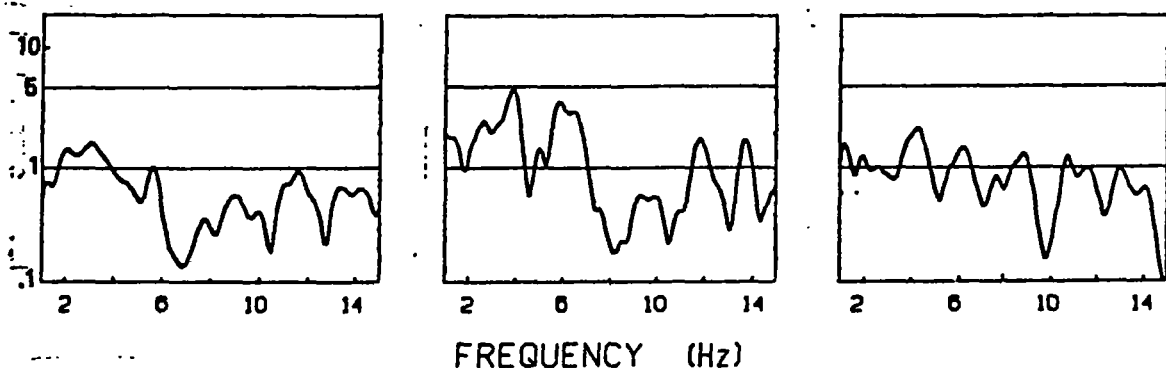
Figure 16.--Spectral ratio comparison for all three components between site 6 and several sites with a damage rating of 5.

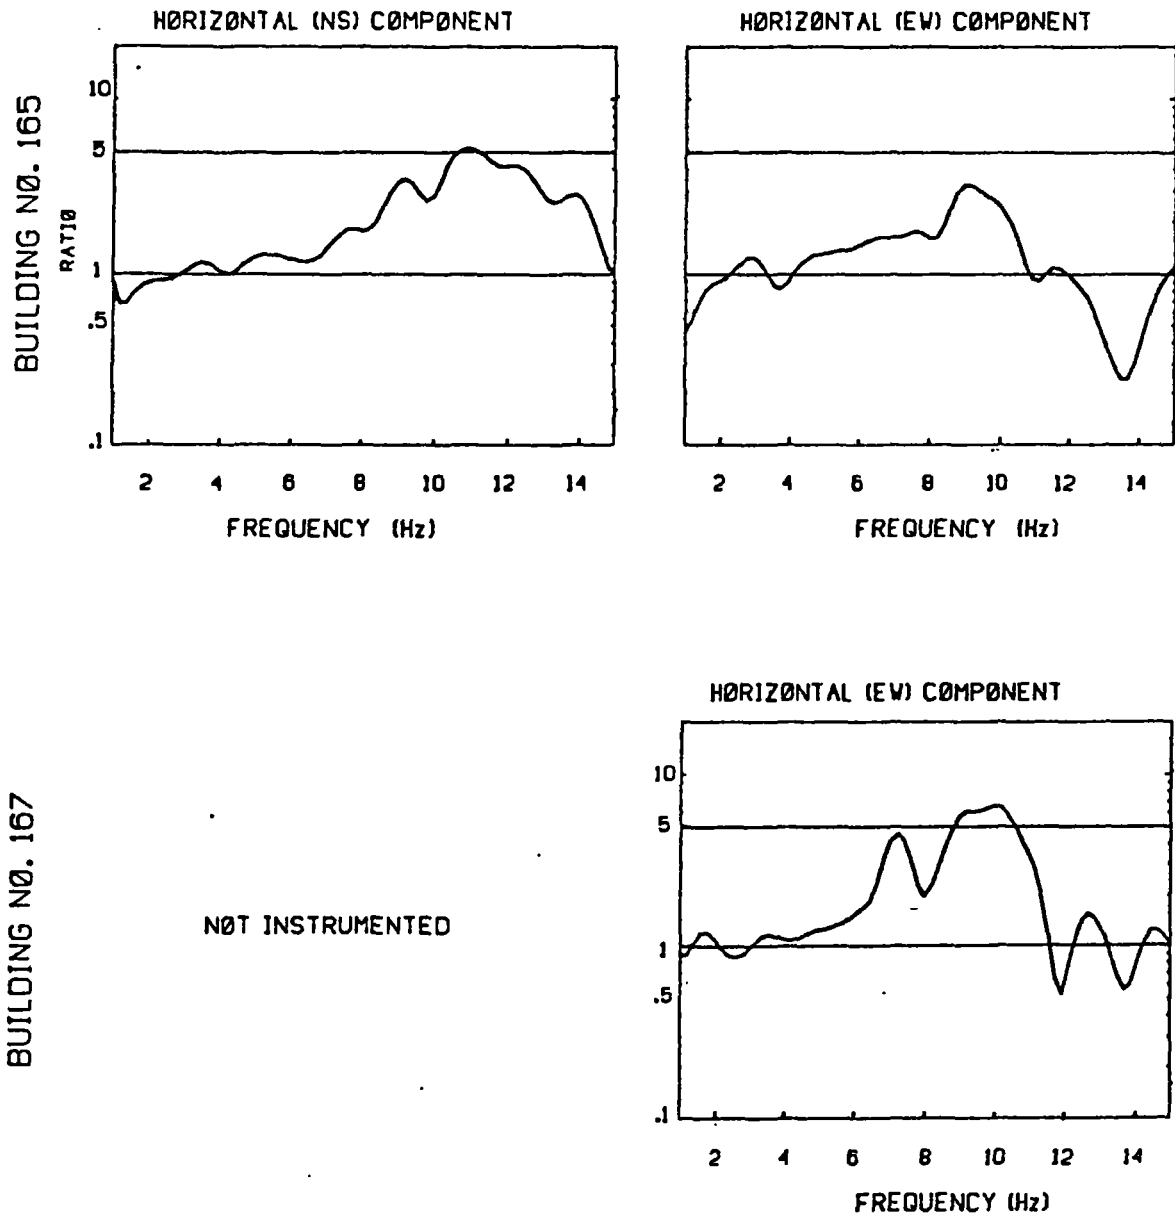
spectra). The ground motion frequencies that are amplified by the structural response depend on the natural frequencies of the structure and the coupling of the building to the ground (Tschebotarioff, 1951). The spectral ratios of the induced motions show that building 165 will amplify most input frequencies between approximately 6-14 Hz with a peak amplification of 5.1 at 11 Hz in the north-south horizontal component and a factor of 3.2 at 9.2 Hz in the east-west horizontal component. Building 167 will amplify frequencies from approximately 6-11 Hz in the east-west horizontal component with a peak amplification of 6.5 for the frequencies from 9-11 Hz in the east-west component (fig. 17).

Figure 17.--The spectra for sites 165 and 167 were ratioed against the ground motion spectra measured one building height from the base of the building. Ratios show the frequencies that are amplified by the structural response of the building.
